EXTERIOR LIGHTING EVALUATION

*Rowan University – Glassboro Campus
Shpeen Hall
Glassboro, NJ 08028*

Pennoni Associates Inc.
515 Grove St
Haddon Heights, NJ 08035

Proj. No. RCFM1701

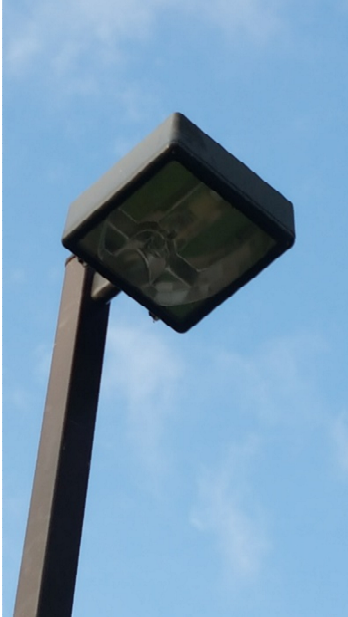
Figure 1 – Shoe Box Luminaire

- 1) Shoe Box – Generally a basic, non-decorative, extruded rectangular body roughly of the proportions of a shoe box. This light fixture is commonly used for parking lots. It is often mounted 20ft to 30ft above grade. Most commonly pole mounted with (1) to (4) heads per pole, but can also be building or surface mounted. See Figure 1 below.

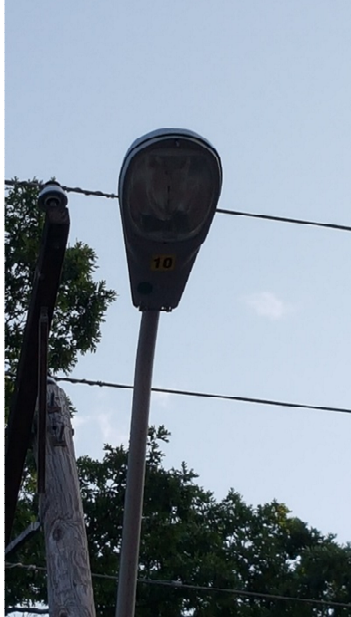
Figure 2 – Cobrahead Luminaire

- 2) Cobrahead - Generally a basic, non-decorative, slightly oval shaped head, often with a slightly curved bracket. This light fixture is commonly used for roadways and adjacent sidewalks. It is often mounted 25ft to 30ft above the road surface. Most commonly mounted with (1) head facing the roadway, perpendicular to the curb to a metal pole or wooden utility pole. See Figure 2 below.

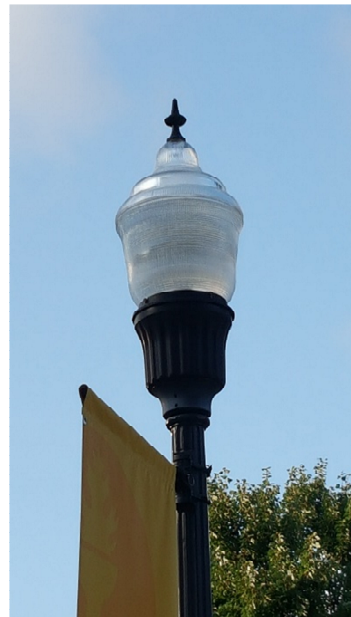
Figure 3 – Acorn Luminaire

- a. Acorns – With a glass or polycarbonate lens roughly in the shape of an acorn. This similarity becomes more obvious with the top shield that looks like the cap of an acorn. See Figure 3 below.

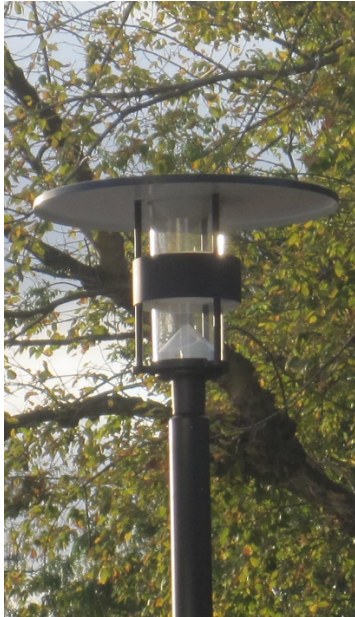
Figure 4 – Indirect Luminaire

- b. Globes – With a glass or polycarbonate lens with a spherical shape.
 - c. Indirect – A luminaire with the illuminating element located below a reflecting surface, where light bounces off the reflecting surface and back down. This can lower the luminaire's efficiency and efficacy, but can also reduce glare by reflecting off a diffused surface. See Figure 4 below.

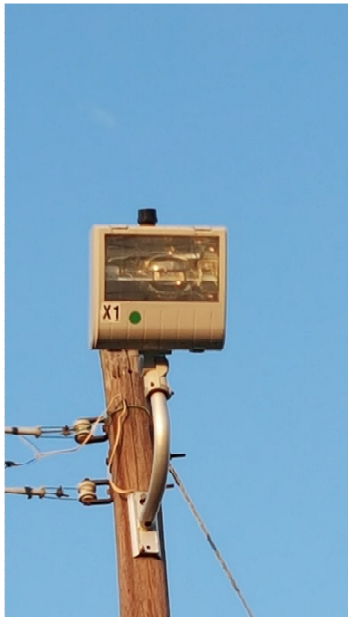
Figure 5 – Floodlight

- 4) Flood light and Spot light – Luminaires with a directed vertical component designed to throw light further forward than the above fixtures. By its nature, they create glare. See Figure 5 below.

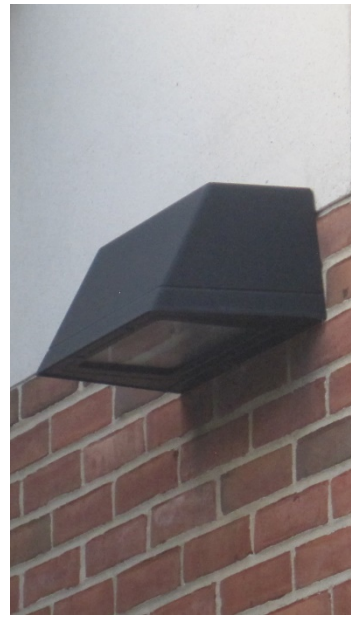
Figure 6 – Wall Pack

- 5) Wall Packs – A general term for all non-decorative, and some simple decorative, roughly boxed shaped luminaires mounted to a wall or other vertical surface. See Figure 6 below.

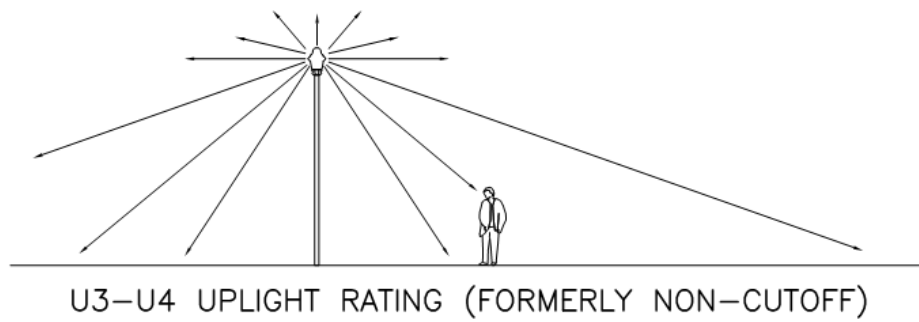
- 2) Vertical Illuminance - Illumination provided by artificial lighting that illuminates a vertical surface such as walls, a person, and building exteriors. See Figure 8 and Figure 8 below for types and effects of different vertical distributions. Better quality lenses and globes can provide vertical illuminance and cut down on the amount of glare. They diffuse or break up the light source(s) to not be as intense directly to the eye (i.e. reduce glare). Lower quality lenses and globes allow the light source(s) being seen directly by the eye, and therefor can cause reduced visual performance or even temporary blindness (i.e. very glary). See Figures 10 – 15 for comparison. This can be dissipated by lower brightness, higher mounting height and/or closer spaced luminaires.

Figure 8 – Diagram of different types of vertical distribution

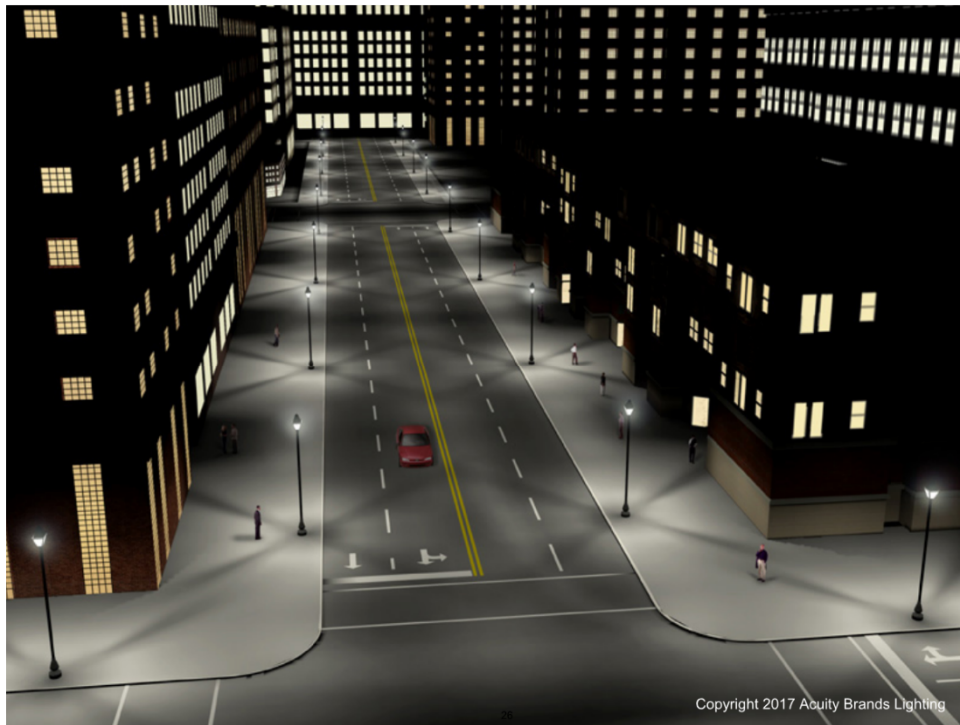
Figure 10 – Render of Full Cutoff Decorative Luminaires without Optical Lenses

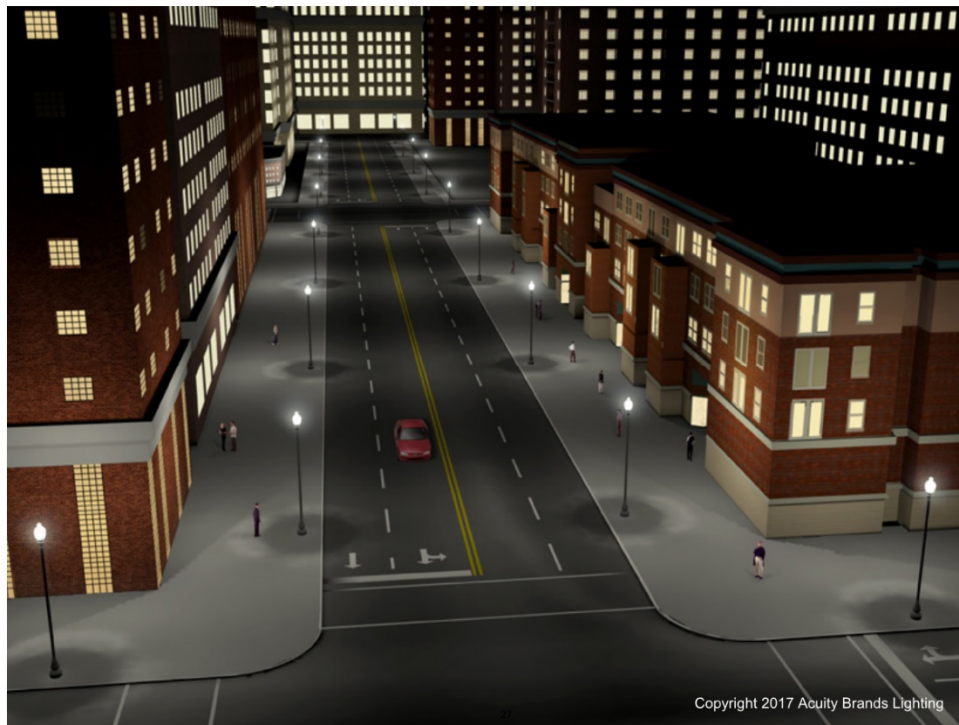
Figure 11 – Render of Semi- or Non-Cutoff Decorative Luminaires without Optical Lenses

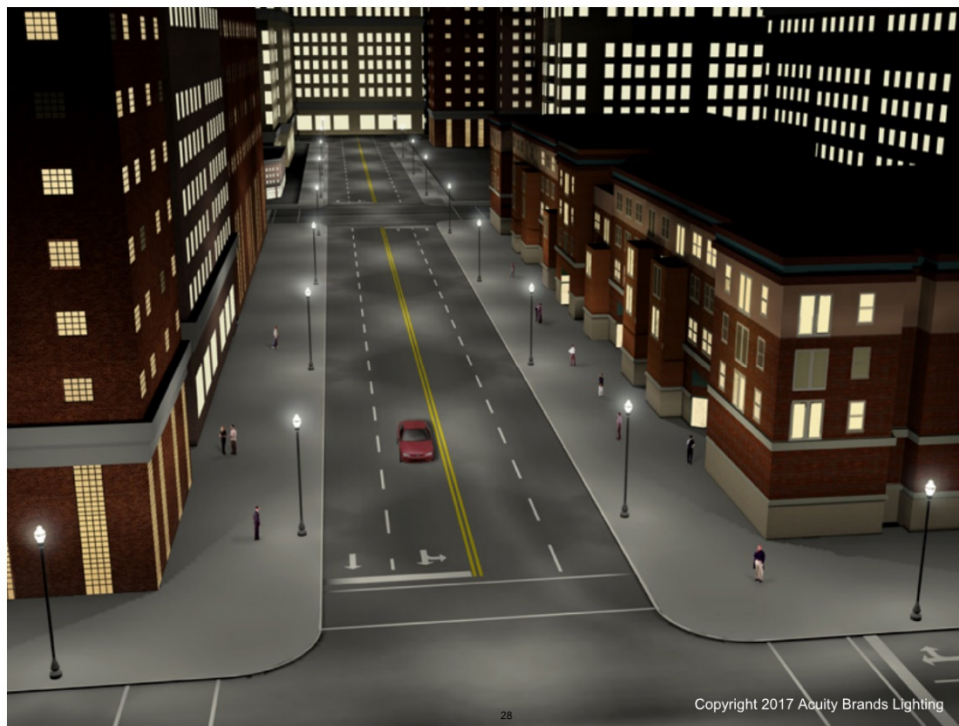
Figure 12 – Render of Semi- or Non-Cutoff Decorative Luminaires with Optical Lenses
